# Campbell STRUCTURAL

Re: City of Somerton 1.0M Gallon Water Tank – Structural Review

APPENDIX A  
PHOTOGRAPHS

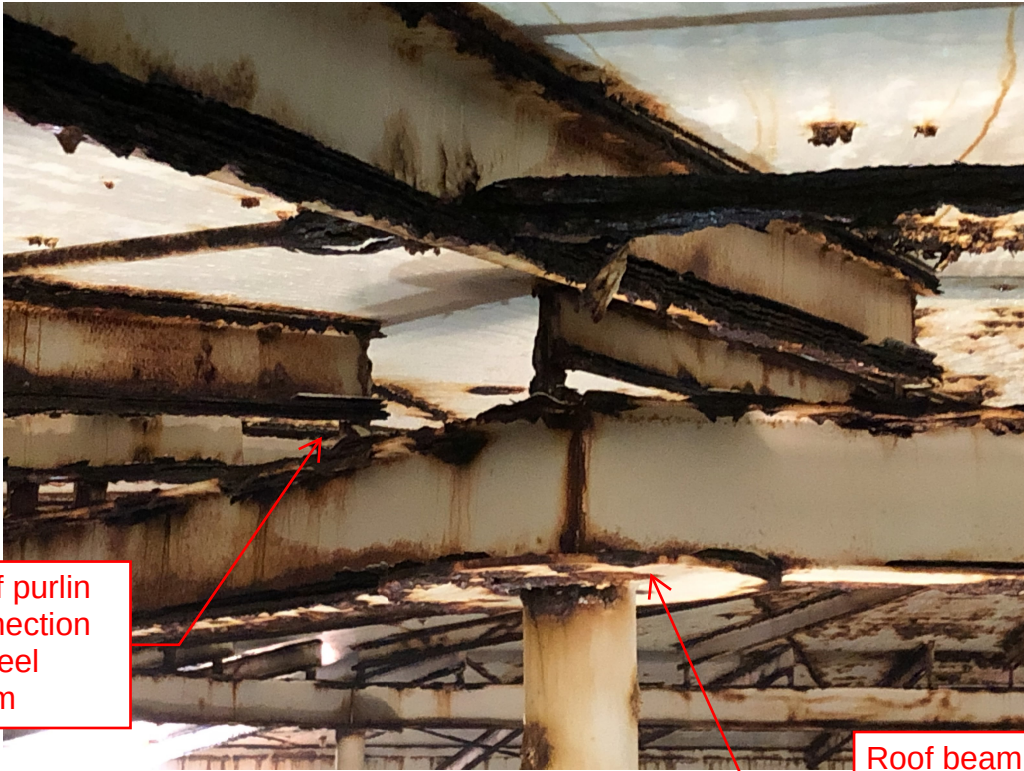
- Tank Roof and Columns:
  - The observed corrosion on the steel roof plate, steel channel rafters and wide flange beams has progressed to the extent of causing failure of the roof structure. In several locations, the steel channel rafters have failed and are dangling from one end, flanges on all channel rafters and wide flange beams are corroded to the point of delamination.

Roof purlin  
connection  
to steel  
beam

Roof beam  
to top of  
steel pipe  
column

1. The roof structure shall be replaced in its entirety. This includes roof plate, rafters and beams.
2. The steel pipe columns, base plates and top of column plates shall be replaced.

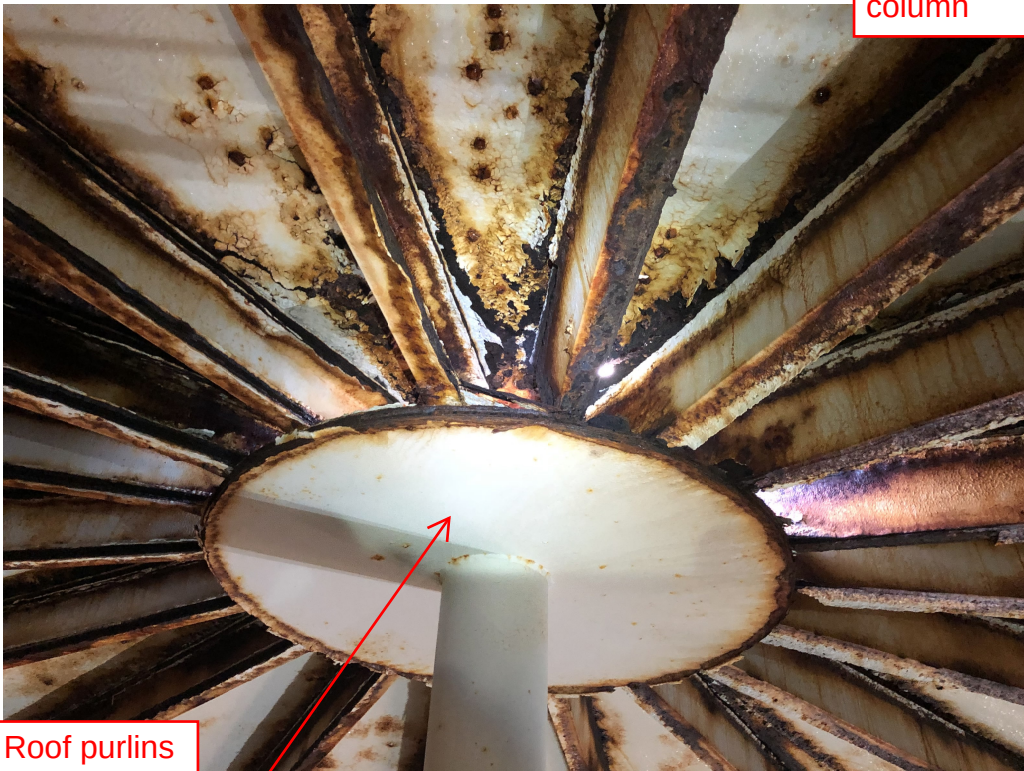
Roof purlins  
connection  
to center  
column
